**ABATTOIR (SLAUGHTERHOUSE) IN
QALADZE
SULAYMANIYAH, IRAQ**

**SIGIR PA-09-179
OCTOBER 16, 2009**

Summary of Report: PA-09-179

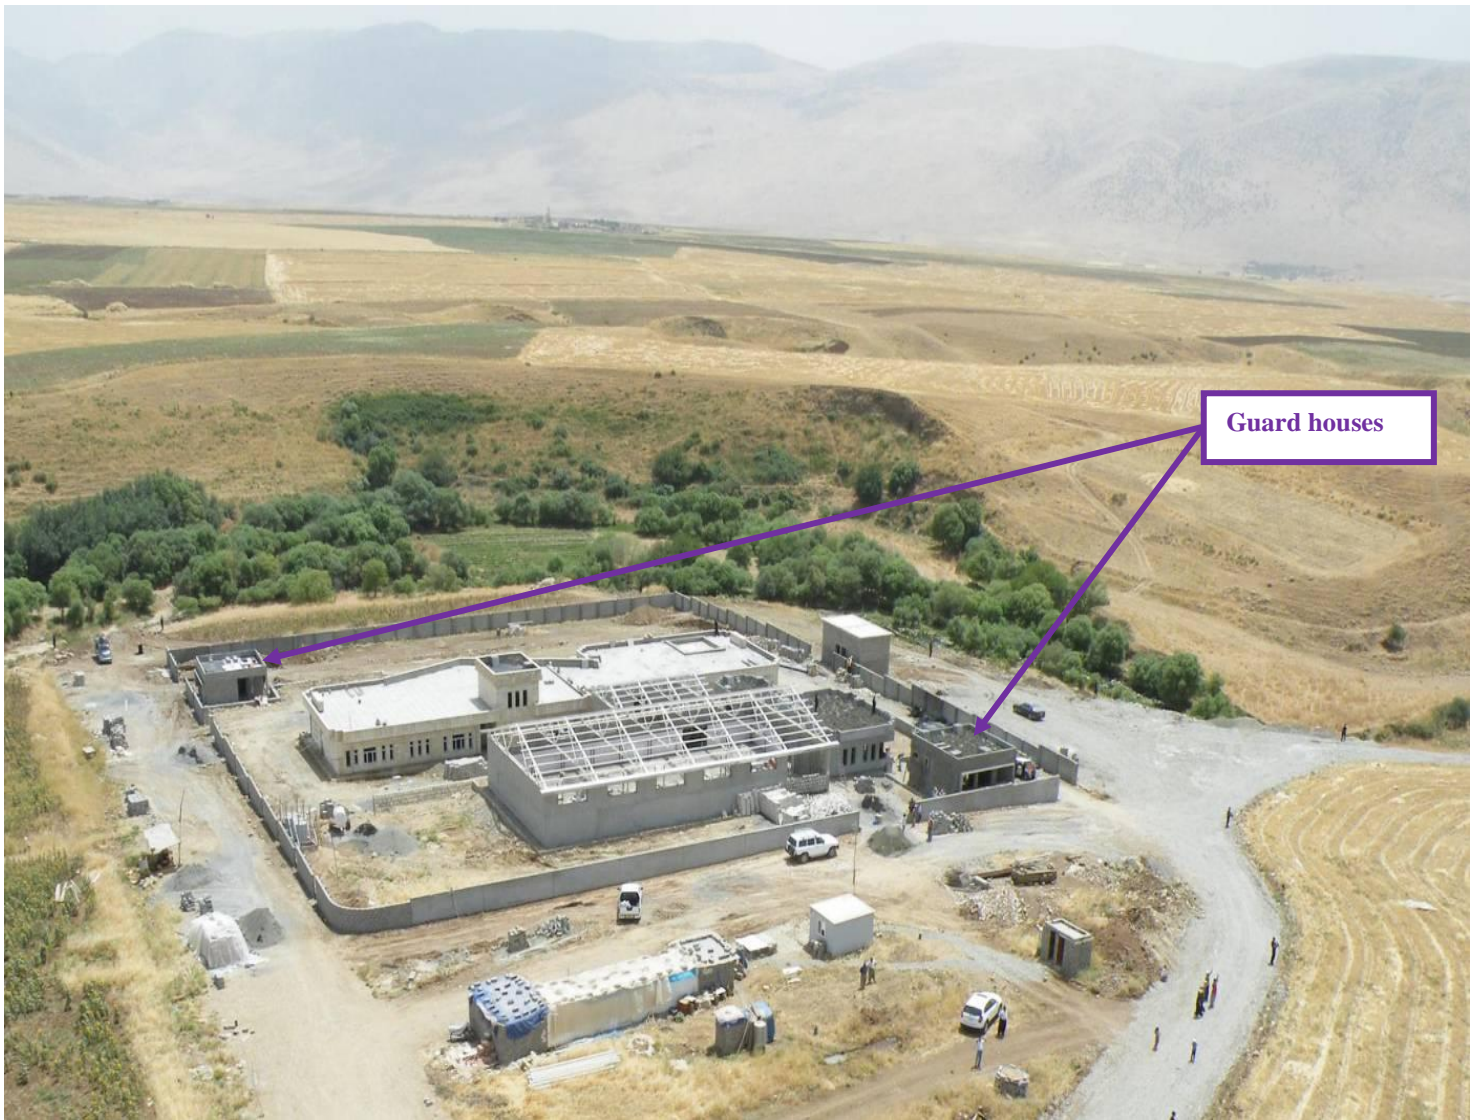
The SOW required the construction of two guard houses (one for each entrance/exit) (Site Photo 6). The designs called for a single-story structure with a kitchen, living room, water closet (bathroom), and storage room.

Site Photo 6. Location of the guard houses within the abattoir facility

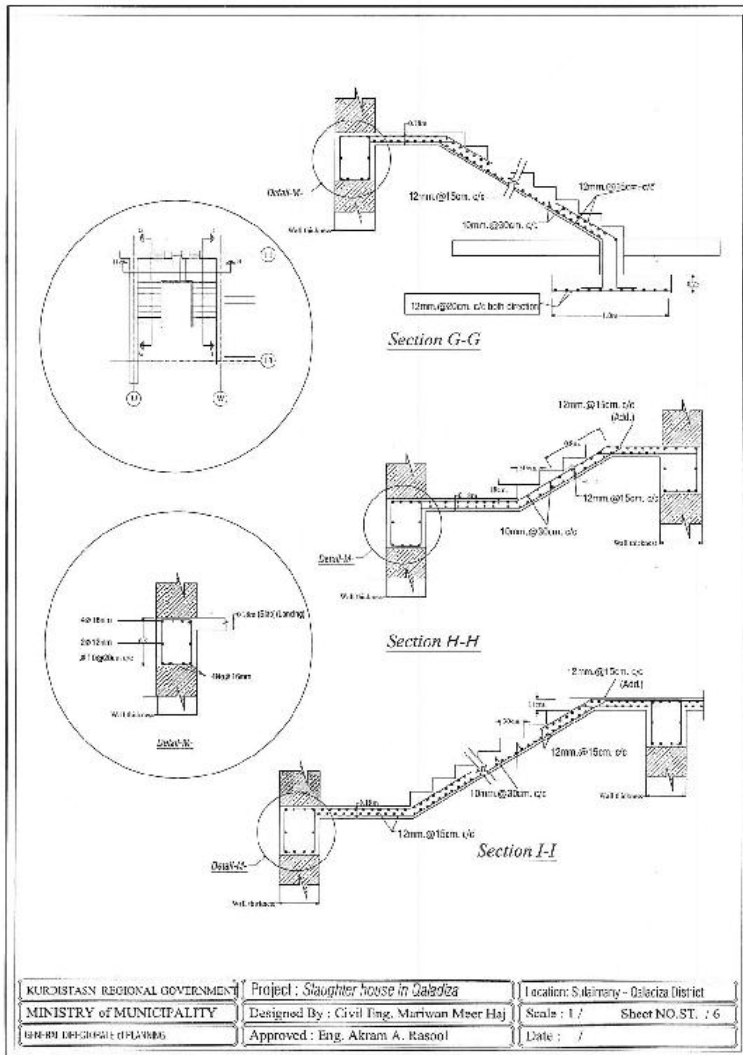
Figure 2. Design submittal for concrete stair unit
(Courtesy of USACE KRO)

Second, SIGIR identified a tripping hazard inside the facility (Site Photo 20). The risers for a reinforced concrete stair unit are inconsistent and not within the dimensional range specified by the building code and detail shown on the design submittal (Figure 2). Specifically, the first step is only 7 centimeters high, instead of the required 17 centimeters. The site condition of the stair unit does not reflect the original design drawing. In order to provide a safe working environment, this tripping hazard needs to be corrected.
